**DEPARTMENT OF TRANSPORTATION**

Contract #: 04-0120F4Cty: SF/ALA Rte: 80 PM: 13.2/13.9File #: 69.28**WELDING INSPECTION REPORT****Resident Engineer:** Pursell, Gary**Address:** 333 Burma Road**City:** Oakland, CA 94607**Report No:** WIR-012468**Date Inspected:** 04-Mar-2010**Project Name:** SAS Superstructure**OSM Arrival Time:** 700**Prime Contractor:** American Bridge/Fluor Enterprises, a JV**OSM Departure Time:** 1900**Contractor:** Zhenhua Port Machinery Company, Ltd (ZPMC), Changxing Island **Location:** Shanghai, China**CWI Name:** Mr. Wuzhi Chang**CWI Present:** Yes No**Inspected CWI report:** Yes No N/A**Rod Oven in Use:** Yes No N/A**Electrode to specification:** Yes No N/A**Weld Procedures Followed:** Yes No N/A**Qualified Welders:** Yes No N/A**Verified Joint Fit-up:** Yes No N/A**Approved Drawings:** Yes No N/A**Approved WPS:** Yes No N/A**Delayed / Cancelled:** Yes No N/A**Bridge No:** 34-0006**Component:** Orthotropic Box Girder (OBG)**Summary of Items Observed:**

**OBG TRIAL ASSEMBLY****LIFT:** 6 West line (Panel Point (PP) #40~47)

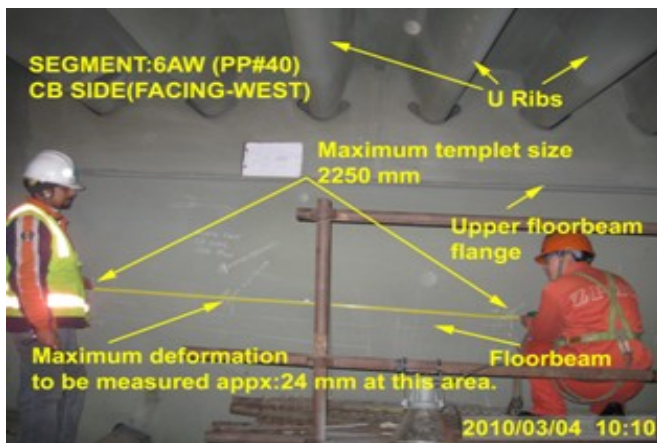
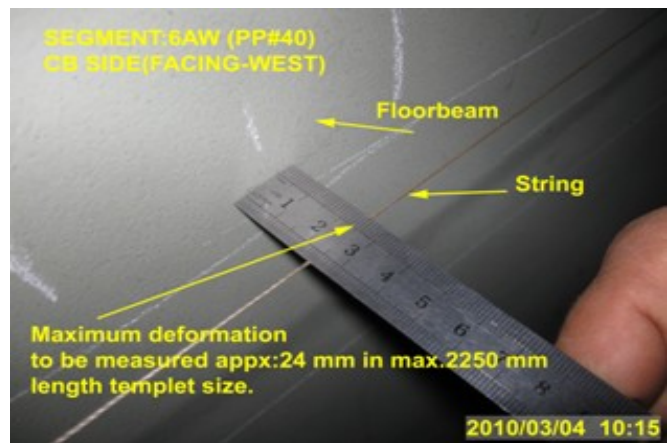
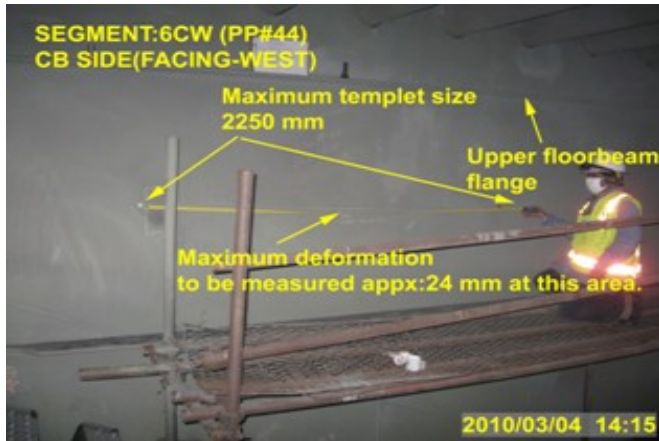
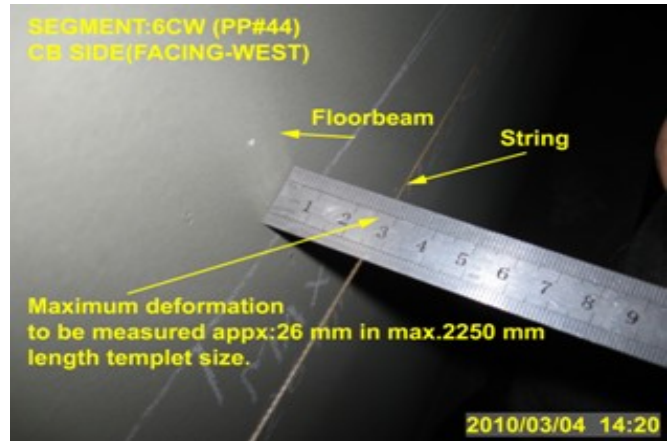
- The Deformation was measured to be approximately 24 mm in 2250 mm Maximum template size.
- The Segment and Panel Point no is 6AW-PP#40 Facing West at Crossbeam (CB) Side.
- The Deformation was measured to be approximately 26 mm in 2250 mm Maximum template size.
- The Segment and Panel Point no is 6CW-PP#44 Facing West at CB Side.

This QA generated a report on this date for the above issue and submitted to the Task Leader for further action. The attached photographs provide additional detail.
